ARTC V/TI MONITOR TRIAL RESULTS AND ANALYSIS

Matthew Dick P.E.
ENSCO, Inc.

Clinton Crump
ARTC

SUMMARY

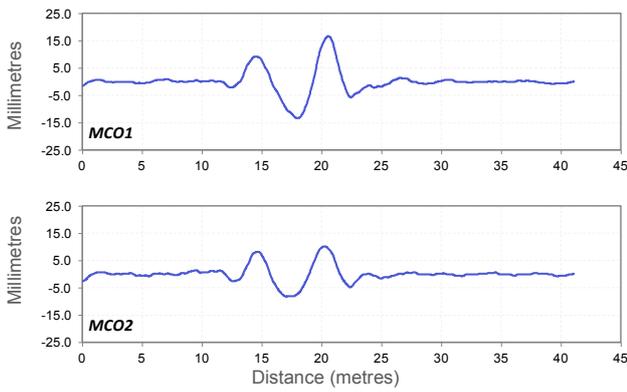
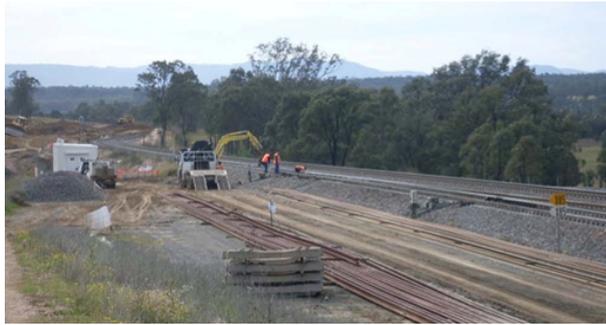
Figure 11 : Example Positive MCO Exception

Figure 11 depicts a positive MCO exception which was +16.7mm. Additionally a driver reported a hole in the road at the location after the V/TI Monitor identified it. A 30 km/h temporary speed restriction was applied and repairs were made.

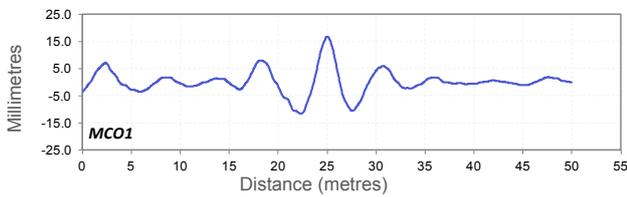
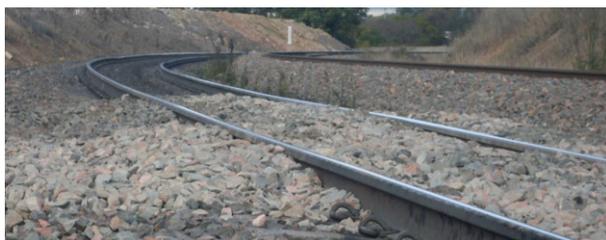
Figure 12 : Example Positive MCO Exception

Figure 12 is another positive MCO exception which was confirmed by a driver. Upon inspection it was discovered that there was a bog hole which created surface irregularities. This is a typical signature of a formation issue.

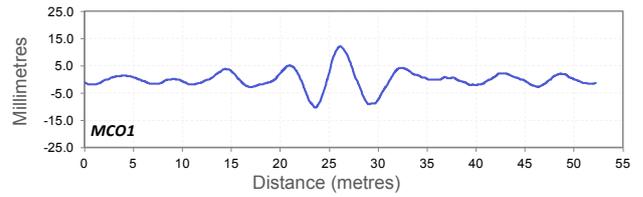
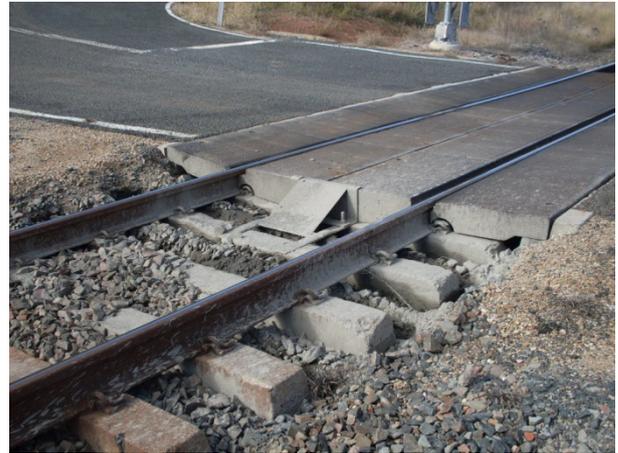
Figure 13 : Example Positive MCO Exception

Figure 13 is yet another example of a positive MCO exception. This exception occurred at a road crossing.

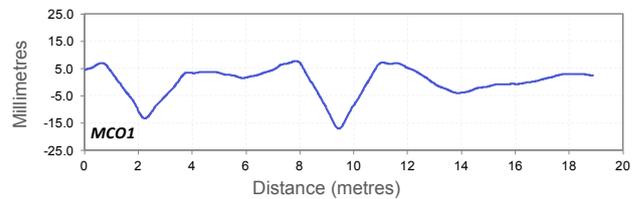
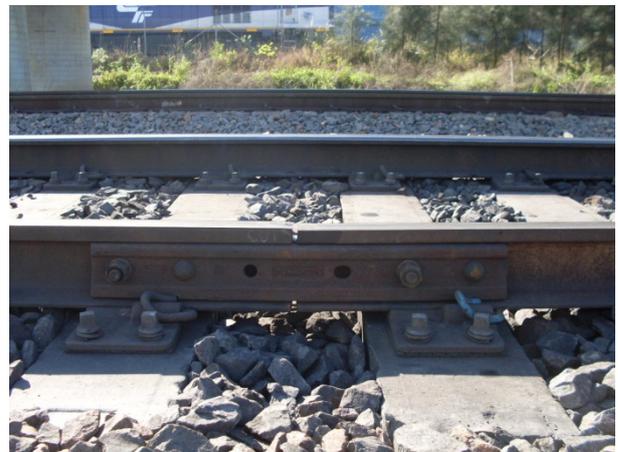
Figure 14 : Example Negative MCO Exception

Figure 14 depicts a couple negative MCO exceptions which was -17 mm. At the inspection, it was discovered that there were two low joints were at the location. This is the typical signature of a pumping insulated and mechanical rail joints.

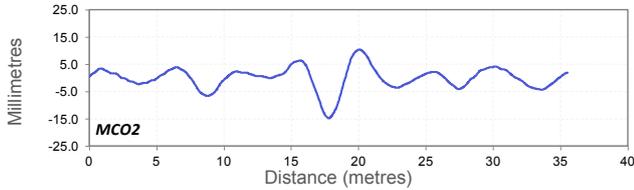
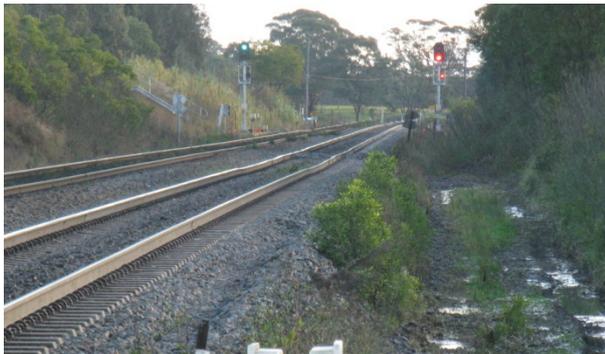
Figure 15 : Example Negative MCO Exception

Figure 15 depicts another negative MCO exception. During inspection it was found that a top condition existed at the site.

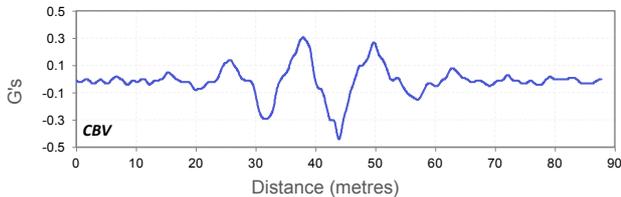
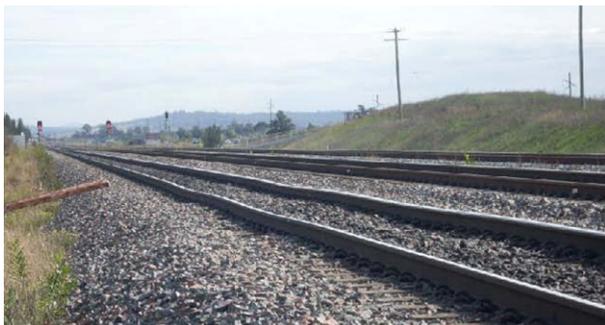
Figure 16 : Example Carbody Vertical Exception

Figure 16 depicts a Carbody Vertical (CBV) exception, which was 0.75 G's peak-to-peak. Inspecting the track, it was observed that it had poor top conditions.
