# THE DEVELOPMENT OF A GEOCOMPOSITE TO PREVENT MUD PUMPING

## ABSTRACT

In 2010 GEOfabrics launched a new anti pumping geocomposite in the UK, which could be placed directly on the sub-grade or on a failed sub-ballast and prevent the development of mud pumping.

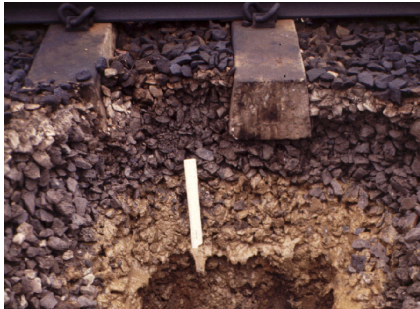
**Figure 1. Ballast Contaminated with Subgrade Fines**

New ballast has an open texture, which allows free water to come into contact with the exposed formation/subgrade surface. If the old formation is in good condition it will be stable and the new ballast will have a long life. However if the exposed surface contains fine grained particles, these can be readily eroded by the water accumulating in the voids, forming weak, highly mobile slurry. This slurry is then 'pumped' up into the overlying ballast by each passing axle load. Contamination of the clean ballast layer by the fine soil particles in the slurry very quickly reduces the load bearing properties of and leads to loss of track alignment in the affected area. Even a small amount of slurry can considerably reduce ballast life. Under extreme conditions the ballast will become unmaintainable within a very short time after installation. Figure 1 illustrates a severely contaminated ballast section as a result of this phenomenon. In this example 200g/sq m non-woven geotextile had been placed over a previously slurried formation in an attempt to hold back the fines, clearly without success. This photograph was taken just one year after installation and the track was already showing clear signs of distress. Figure 2 shows a typical example of severe track misalignment (vertical and horizontal) resulting from a mud pumping failure.

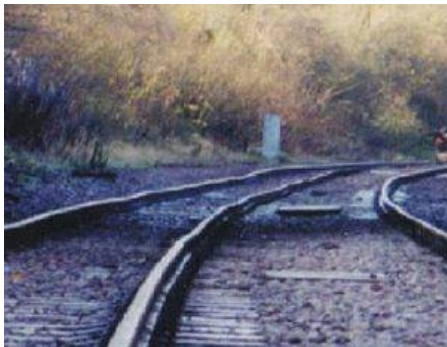
**Figure 2. Misaligned Track Section Due to Subgrade Pumping**

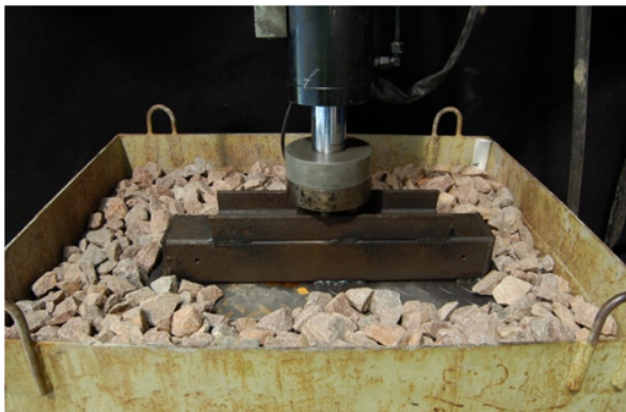
**Figure 3. Half-Scale Test Rig**

Small scale laboratory test rigs such as that shown in Figure 3 is particularly useful for rapid assess to use in development efforts. This rig models the performance of a sleeper, ballast and clay subgrade combination at realistic loads. While this rig is useful for preliminary evaluation of the potential of new “concept” geocomposites to address subgrade pumping, it does not include the effects of shear stress reversal between sleepers which occurs under a moving load. In order to fully demonstrate the properties of a new product and reduce the need for site trials it is important to undertake testing at full scale in a rig that can simulate a moving load.

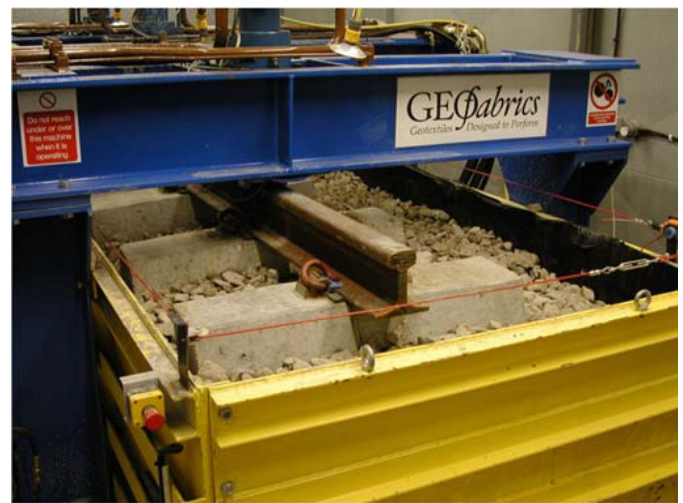
In 2001 a new full scale test rig was installed, as shown in Figure 4. It consists of a half-track panel (i.e. single rail supported on seven half-length but otherwise full dimension

sleepers) seated on a box measuring 4.5m by 1.5m by 1.0m deep which contains the track bed.

**Figure 4. Full Scale Test Rig**

The tank is watertight, with drainage points available at set levels facilitating the ability to examine the effect of poor drainage and a high water table. Spray head nozzles are located above the ballast, giving the ability to simulate rainfall. Load is applied by three computer controlled hydraulic actuators to apply real rail loading profiles up to ten times per second. Introducing a time delay between the profiles simulates a rolling load. This simulated a maximum axle load of 20Tonnes passing at a maximum frequency of 3Hz.

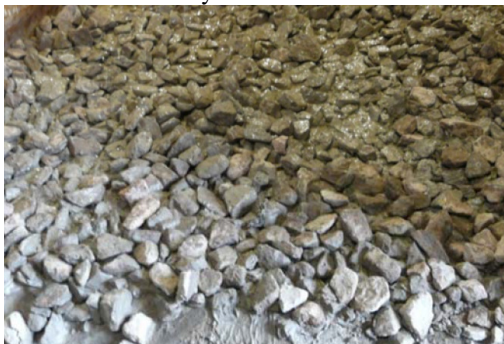
**Figure 5. Failed Formation (pre-test)**

- the subgrade was a remoulded firm/stiff Oxford Clay (typically 80% clay sized particles - <math><2\mu</math>). This is considered to be one of the most erosion susceptible soils.
- a 275mm thick layer of open graded ballast was placed directly over the unprotected subgrade. Water was added to the box such that the water level was maintained 50mm above the clay surface. Experience has shown that 200,000 cycles of maximum load would be required in order to generate sufficient slurry.
- Once slurry had formed, 200mm of ballast was excavated to reveal a slurried sub-ballast, ready for the trial geosynthetic to be installed (see Figure 5). This condition represents the harshest environment under which any geosynthetic could be expected to experience in a track situation.

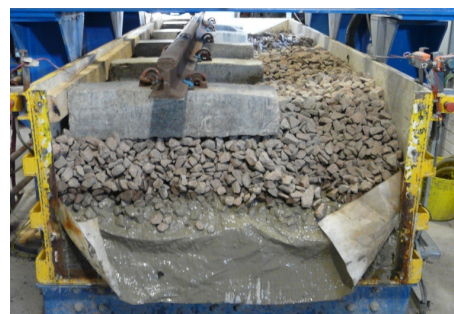
**Figure 7. Failed Geotextile Separator After 1 Million Load Cycles**

Figure 6 show the test set-up for assessing the performance of trial geocomposites. The first material to be trialed under these harsh conditions was a conventional 400g/m<sup>2</sup> non-woven heat bonded geotextile, in order to replicate known performance of a conventional geotextile. The water level was maintained at 50mm above the level of the geotextile. 1 million cycles of the maximum load were then applied. As expected the slurry continued to rise in the ballast, appearing not to be slowed by the geotextile. Figure 7 shows the results as the end was removed from the rig.

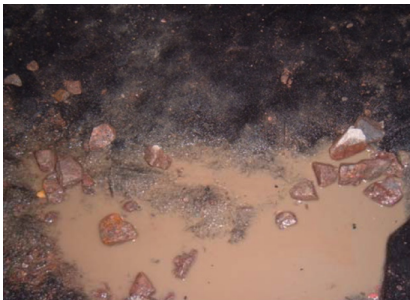
Initial testing on the large rig subjected the composite to 3.7 million cycles prior to any excavation; this simulates approximately 70 million gross tons of heavy traffic. During the test water level was maintained at 50mm above the geotextile surface. Water above the specimen was drained upon completion and the ballast was removed to allow inspection of the upper surface of the composite. There was no sign of slurry above the composite but the water that had collected in the deformations beneath the sleepers was dirty. Initially, it was believed that some finer clay particles had migrated through the composite. However, further investigation showed that the surface felt gritty, indicating that much of the material above the prototype was the result of ballast attrition, not fines migration (See Figure 8).

**Figure 8. Top of Geocomposite After 70 Million Gross Tons of Loading**

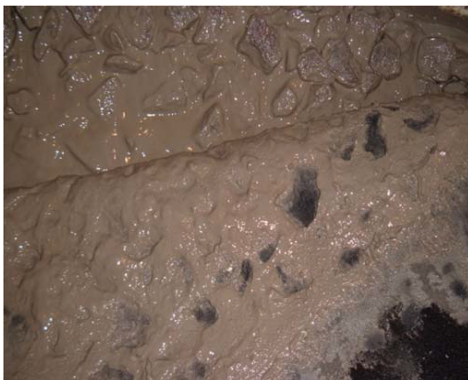
The composite was then rolled back to reveal the underside. The underlying ballast was full of wet slurry. The slurry adhering to the underside of the composite was stiffer (more viscous) than the slurry in the ballast voids, indicating a lower moisture content. This process had been observed beneath sand blankets in the past. The action of cyclical loading had squeezed the water out of the slurry leading to desiccation as illustrated in Figure 9.

**Figure 9. Underside of Geocomposite after 70 Million Gross Tons of Loading**

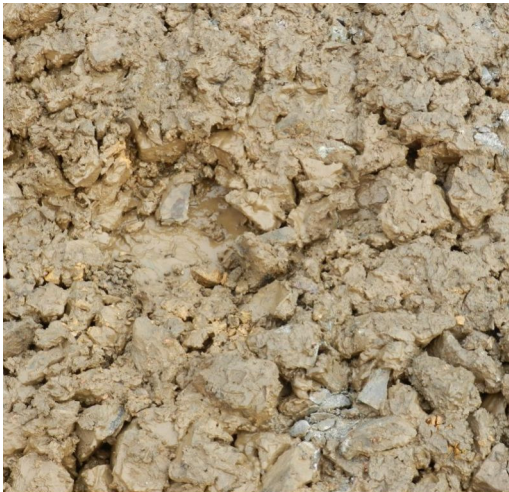
**Figure 11. Slurred formation at Bradley Junction, prior to laying Geocomposite Microporous Filter**

In 2009 Network Rail decided that the Up Line through Bradley Junction was life expired and would not be able to carry the proposed increase in annual tonnage from 6 million to 11 million. An investigation undertaken in 2010 (Scott Wilson, 2010) described the track bed as variable, with very dirty waterlogged ballast and evidence of upwards migration of clay formation which had caused track geometry to deteriorate rapidly (Figure 11). The report originally recommended approximately 210 meters of sand blanket to protect the existing formation. The specification for the sand blanket was 100mm sand with a geotextile separator to prevent intermixing with the ballast.

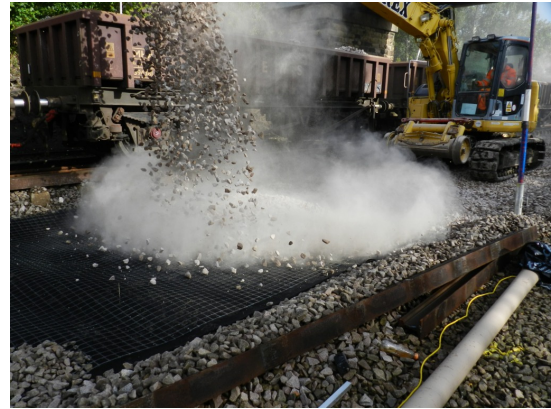
**Figure 12. Geocomposite Microporous Filter Installation**

However, this proved to be a suitable application for the newly developed geocomposite microporous filter which was designated to be installed over areas of previous formation failure instead of the traditional sand blanket/geotextile treatment. In September 2011, Network Rail performed the installation which also included a geogrid placed above the geocomposite filter to reinforce the ballast as compensation for the reduced construction depth over what would have been required if a conventional solution had been applied. The work was undertaken in three consecutive weekends. The decision to use geocomposite microporous filter over the part of the site with formation failure enabled the excavation depth to be maintained constant throughout. Figures 12 and 13 illustrate the installation process and current conditions of the track.

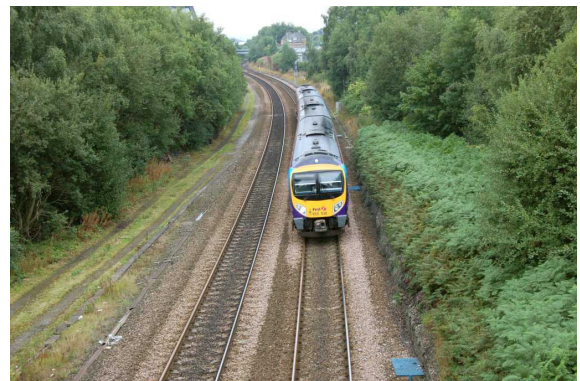
**Figure 13. Bradley Junction Installation as of Today**

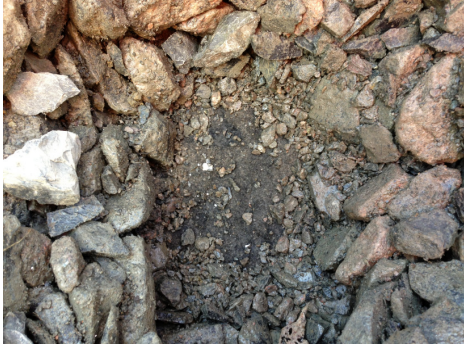
At the time of writing of this paper, the subject area is still performing well and has not shown any signs of continued pumping failure. In recent evaluation of the project (URS, 2013), a series of test pits were excavated to determine the effectiveness of the rehabilitation. As shown in Figure 14, a test pit in the same location at the area shown in Figure 11 (pre-rehabilitation), there is no evidence of subgrade pumping or ballast contamination above the geocomposite microporous filter. The success on this early installation has lead Network Rail to specify geocomposite microporous filter for use in all situations where they would have used a sand blanket/geotextile combination in the past with the exception of high-speed lines. Evaluation for use on lines including high speed corridors is currently underway.

**Figure 14. Test Pit at Bradley Junction - After Reconstruction with Geocomposite Microporous Filter**
