COMBAT RAILWAY EMBANKMENT PROBLEMS

Geocells Protect Railroads Against Potential Impacts of Climate Change

Case Study: Protecting an Adjacent Railroad Line from Future Landslides

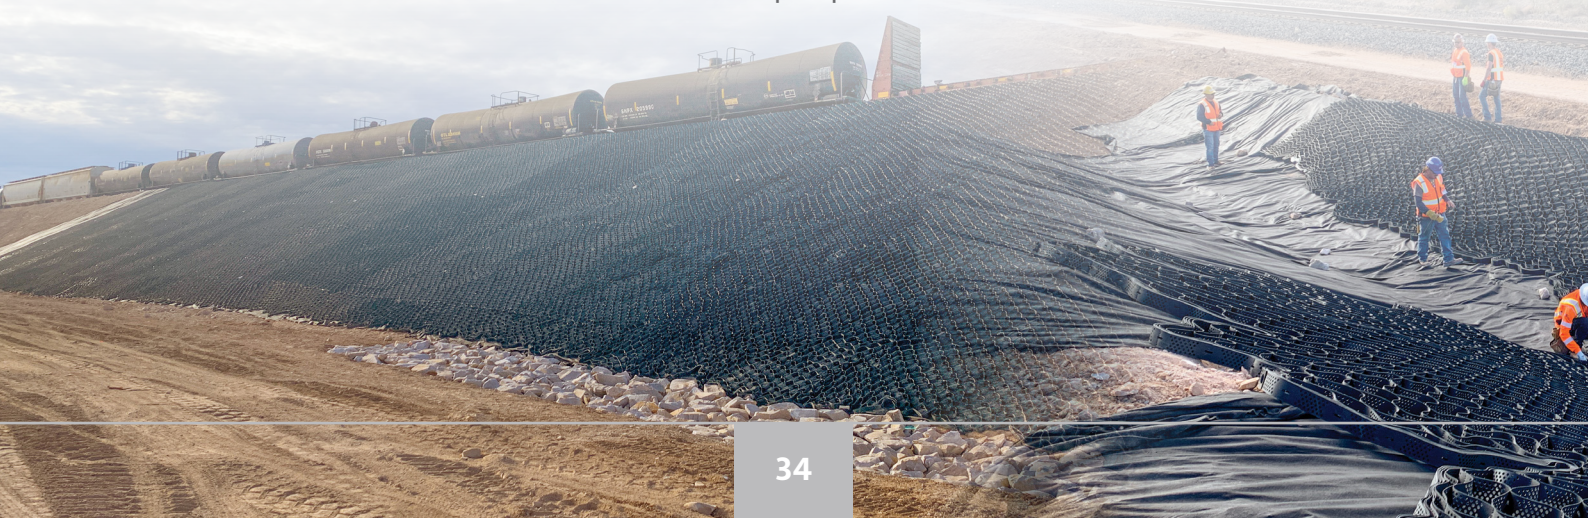
A record rainfall event created saturated soils, resulting in a major landslide near Castle Rock, Washington, on the railroad’s busy double-track mainline between Portland, Oregon, and Seattle, Washington. The landslide blocked heavy freight and passenger traffic for five days, resulting in costly downtime. Prior to this major shutdown, the site’s wet conditions caused smaller traffic-blocking slides, but due to the increased frequency of the landslides, the project owners, engineers, and contractors needed to find a viable solution to stabilising the embankments.

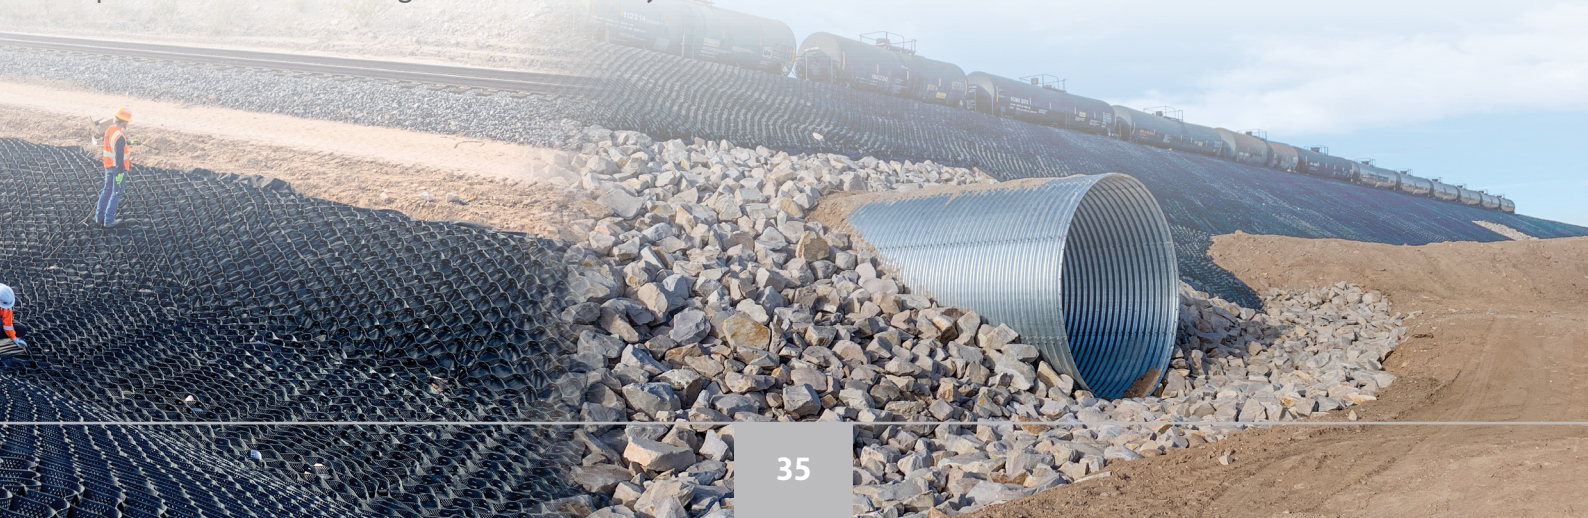
Available as emergency repair 'kits', the GEOWEB Geocells are ideal for providing an immediate response to unexpected repairs. In the US, Class 1 railroads stock this material regularly so they can quickly respond to such unforeseen circumstances. The GEOWEB stock covers 2,700 square feet with one pallet or 120,000 square feet for a truckload. Each GEOWEB section is packaged in collapsed, easy-to-handle sections that are 8.5ft x 27ft. The repair kits come with the ATRA® key connection device – a turn-and-lock key, that is three times faster and stronger than stapling.

The GEOWEB emergency repair kits are ideal for constructing and repairing track ballast, access roads, embankments, earthen berms, bridges, channels and right-of-way areas.
