# CASE STUDY

## CRITICAL MAINLINE STATION

**Fault finding with  
CableGuardian**

# CABLEGUARDIAN SYSTEM AVOIDS POTENTIAL SIGNALLING POWER FAILURE AND DELAYS TO PASSENGERS WITHOUT NEED OF A POSSESSION.

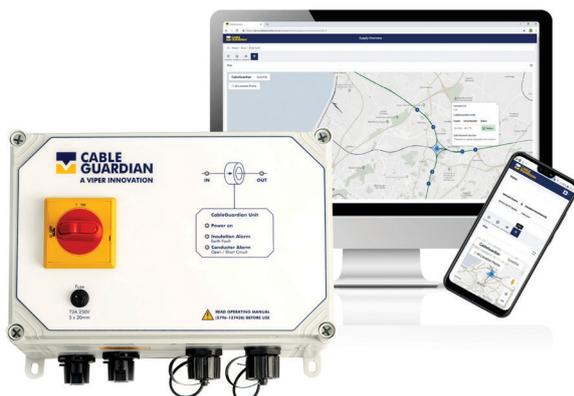
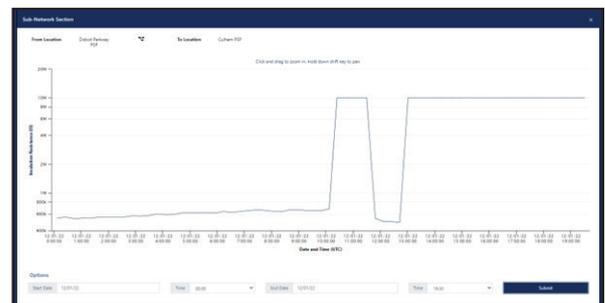
**CableGuardian** portal showing IR readings for the Sub-Network Section.

The data captured indicated that the insulation resistance for the specific section of cable was 0.55MΩ, well below the expected value for that section. The cable section was isolated, and a manual test confirmed the measurement taken by the **CableGuardian** unit.

The faulty cable was left isolated as it was supplying up to an open point at the end of a dual end fed system. Once isolated, the local insulation resistance on the feeder increased to  $>10M\Omega$ .

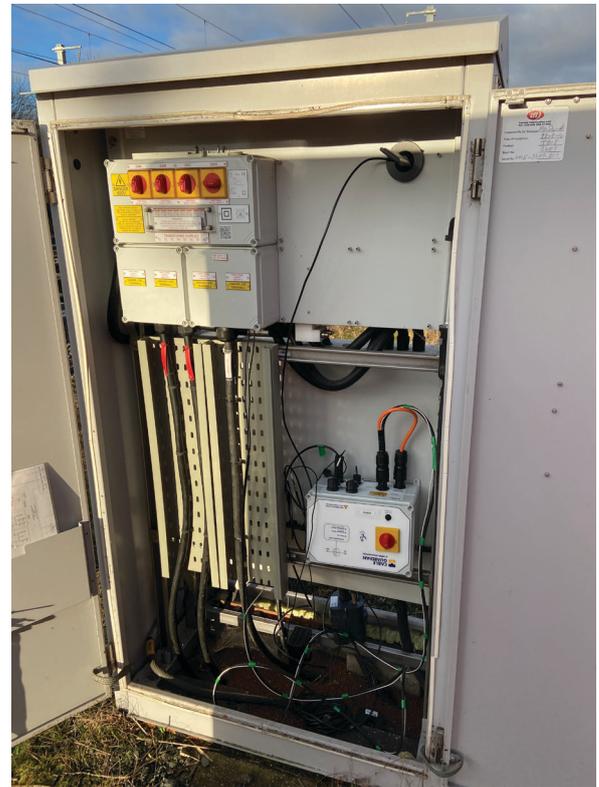
Temporary installation of roaming **CableGuardian** unit, which also offers the flexibility to be fitted upside down if needed. No special requirements for installation.
