ARTC V/TI MONITOR TRIAL RESULTS AND ANALYSIS

Matthew Dick P.E.
ENSCO, Inc.

Clinton Crump
ARTC

SUMMARY

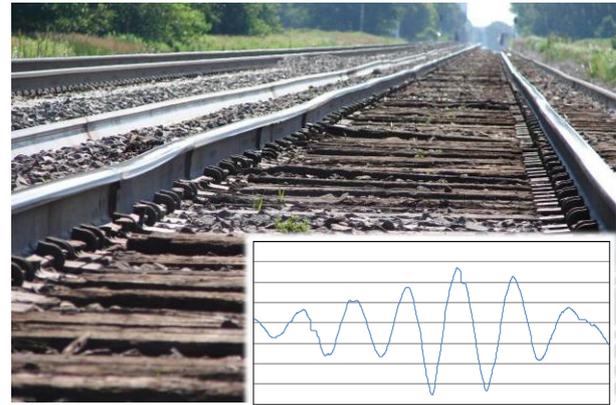
Figure 2 : Example Carbody Vertical Exception

Typically these exception are caused by repeated track top irregularities which excite the vehicle with pitch and bounce motions. An example is shown in Figure 2. This measurement is speed dependent because a vehicle's suspension behaves different at different speeds.

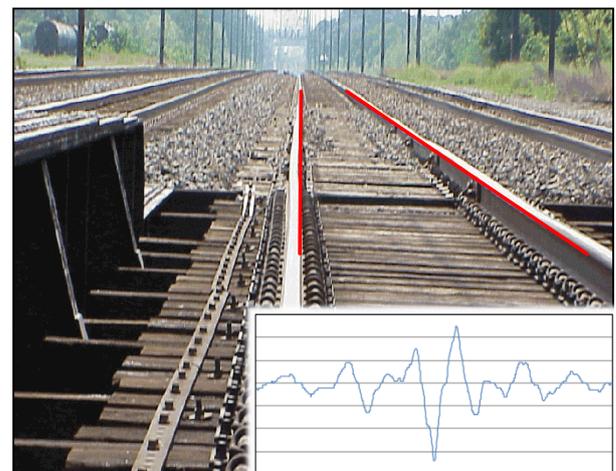
Figure 3 : Example Carbody Lateral Exception

Typically these exceptions are caused by track alignment irregularities. Most commonly it detects lateral alignment conditions at bridges due to settling conditions. An example is shown in Figure 3.

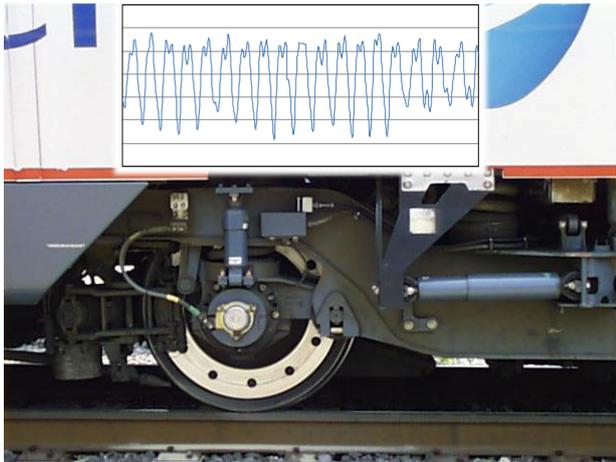
Figure 4 : Example of Truck Lateral Exception

These exceptions are processed to determine continued oscillations caused by bogie hunting. This is done by calculating the exception value as a Root-Mean-Squared (RMS). Typically these exceptions are not caused by track conditions. Rather they are typically caused by vehicle conditions such as worn suspension components or wheel profiles. An example is shown in Figure 4.

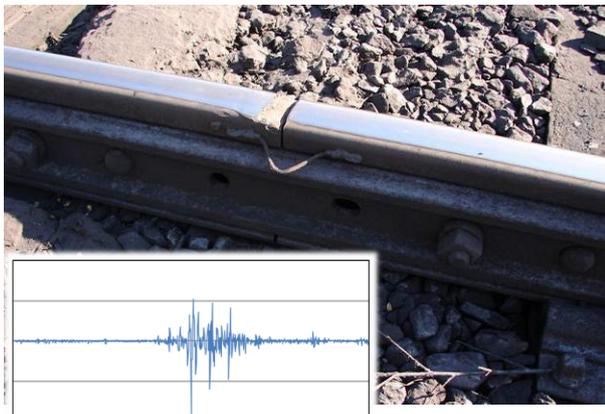
Figure 5 : Example Axle Vertical Exception

Typically these exceptions are caused by wheel/rail impact conditions caused by battered joints, chipped switch points or frogs, wheelburns, broken joints, or broken rail. An example is shown in Figure 5.

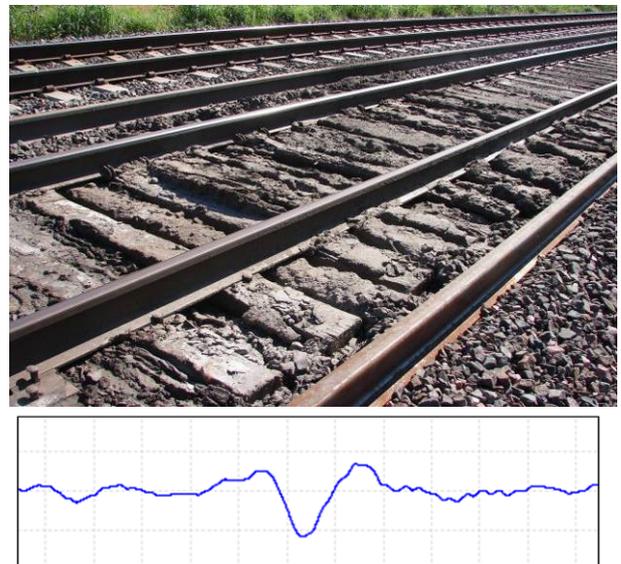
Figure 6 : Example Mid-Chord Offset Exception

An important aspect of this short chord top measurement is that it focuses on top conditions that not only create track geometry risk, but also increased rail stress and associated failure risk. Typically MCO exceptions are caused by bog holes and pumping joints. An example is shown in Figure 6. Additionally, this short chord top measurement is advantageous with a V/TI Monitor because of its ability to continuously monitor track conditions to catch rapid top changes and deterioration rates. The MCO is also a good indicator of underlying track stiffness thus assisting with the prioritization of major subgrade rehabilitation.

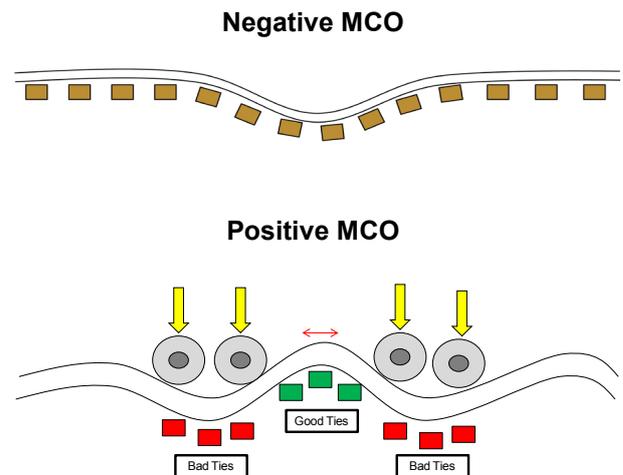
Figure 10 : QRN 5000 Class Locomotive with V/TI Monitor Installed.

During the field inspections, it was quickly observed that there were differences in positive and negative MCO exceptions. Negative MCO exceptions are typical of pumping joints or bog holes where the track is physically depressed downward. However, positive MCO exceptions are generally caused by two downward depressions causing an upward heave in-between. When measuring this condition with a chord at the mid-point, it produces a positive value. Both a negative and positive MCO top condition create tensile stress in the rail that can cause increased risk of broken rail. However, a positive MCO exception places the rail in significant tensile stress on the top of rail. This in combination with common rail head stress concentrations such as spalling or gage cracks can cause a significant risk of broken rail due to fatigue fracture. Figure 10 is a schematic that outlines the differences of the negative and positive MCO exceptions.
