MARKAL INSIGHTS

Recommendations for safety and efficiency following bolt failure that caused factory fire in England

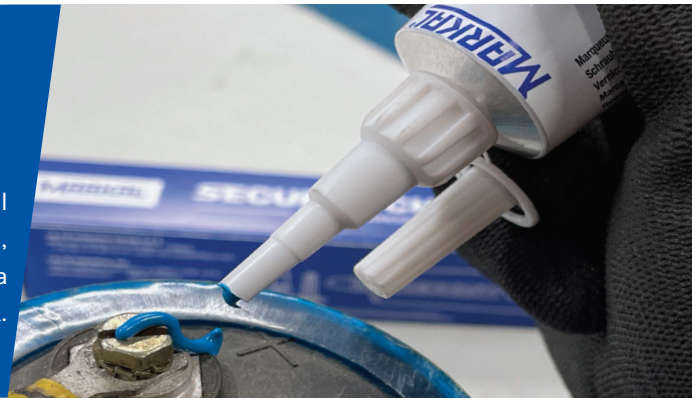
SECURITY CHECK PAINT MARKERS provide a convenient visual method for identification of vibratory loosening or tampering in nuts, bolts, fasteners, and assemblies. High visibility paint mark becomes a hard film that breaks easily. Ideal for quality control and warranty work. Safe on most surfaces, adheres perfectly to metal.

Security Check Paint Markers provide an easy, reliable way to make critical bolt movement visible. A single line of high-visibility paint creates a tamper-evident mark that fractures with vibration or loosening—instantly revealing loss of torque or unwanted rotation.
