GEØabrics®

Ballast Protection Improvement

Christiansburg, Virginia

CASE STUDY

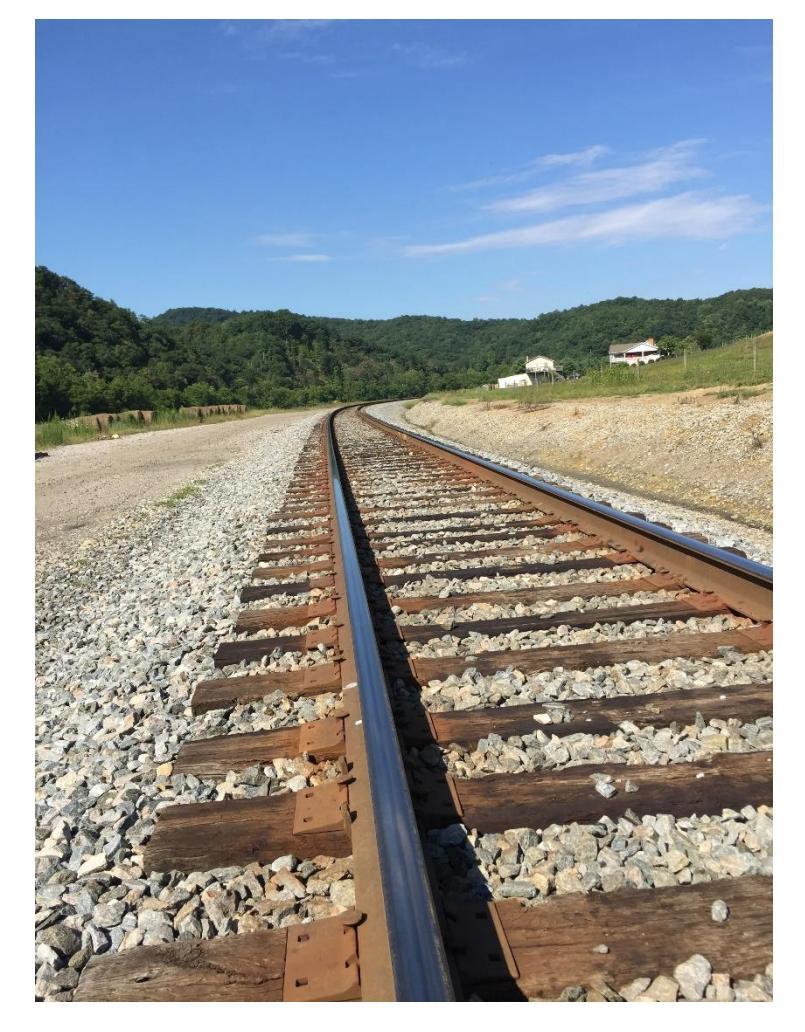
The initial test sections were installed in 2014, and by December 2016, several mud boils had developed in the low-side shoulder of the track which were then removed by an excavator. Photos were then taken during an inspection in April 2017 that showed the clean crib ballast.

It was determined after the two and half year inspection that the Tracktex that had been placed was very effective. It completely covered the limits of a very weak substructure. Within its 25 meters were a low spot and a saturated subgrade. East and west of the Tracktex, the track surface was good, ballast was clean, and there was no evidence of water seeping from the roadbed.

It was concluded that the installation of the TrackTex had prevented the subgrade from fouling the ballast section, and by more effectively distributing the vertical loads to that subgrade, it has greatly extended surfacing cycles and the life of the ballast.
